BRIDGE THEATER FEASIBILITY STUDY

LURAY, VIRGINIA

FEASIBILITY REPORT

March 2012

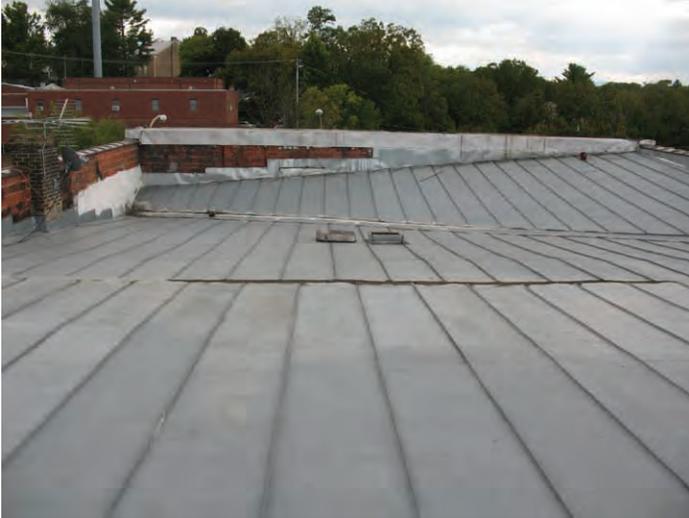
View of the roof looking toward the front of the building showing the exit of the drainage through the parapet on the left hand side.

The existing standing seam galvanized metal roof is reported leaking and has a number of locations that have been patched or that are potentials for leaks in the future. It has an intermediate ridge, which directs water to the front and rear of the building. The water directed toward the front of the building exits through a scupper in the east parapet wall at the southeast corner. An enclosure that presumably includes the downspout can be seen on the building exterior in this location. The water directed toward the rear drains into a metal gutter and downspout that empties onto grade. A section of the clay tile parapet wall coping is missing and a rubber membrane has been added to temporarily address this. The roof of the one story addition was not accessed for this report.

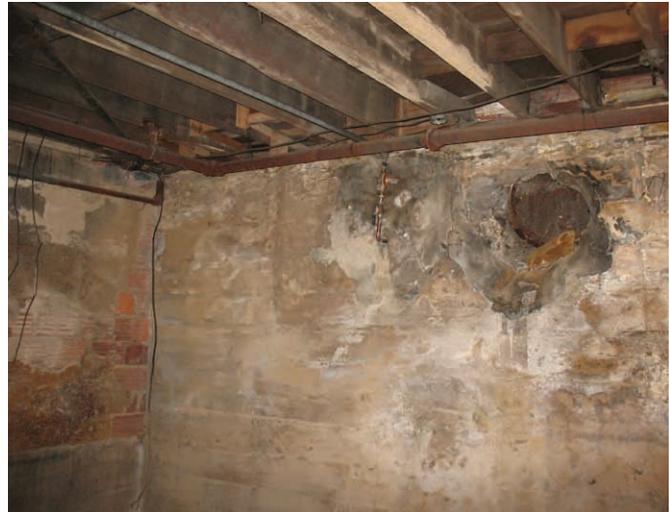
A concrete foundation wall was visible along the south end of the main section of the building which transitions to the structural terra cotta tiles as it turned the corner on the east end. Wood floor joists measuring 2" x 10" at approximately 16" on center and running the long direction of the building were visible in this same space. These joists terminate at large, solid wood girders running perpendicular to the long direction of the building. Both these girders, and the solid wood posts they rest on, showed deterioration in some locations. These beams along with the relatively large cracks in the CMU in the basement of the one-story addition should also be further investigated.

View of the foundation wall and framing at the south side of the building.

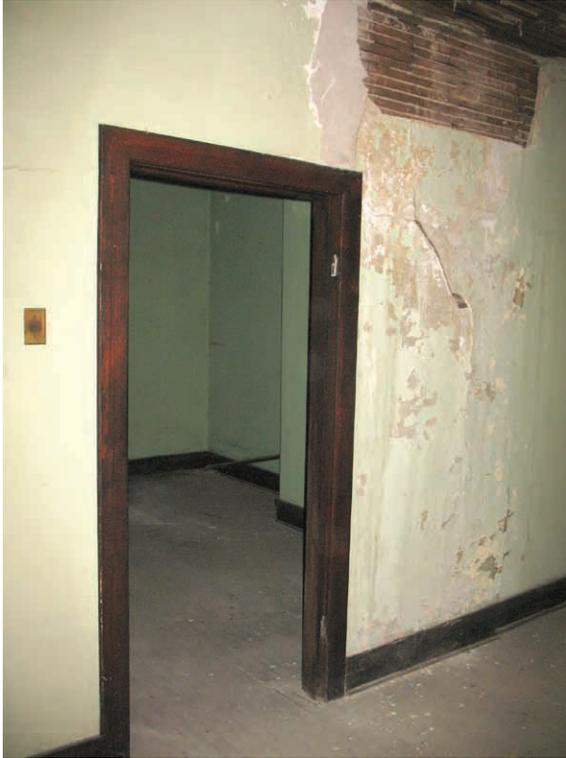
View of plaster damage on second floor.

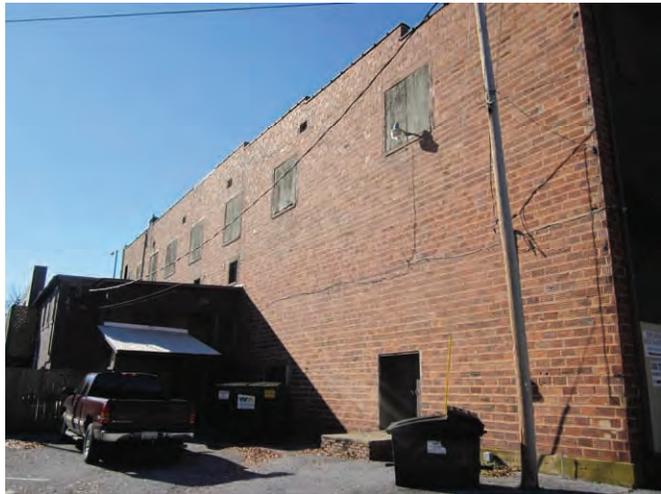
East theater wall

The foundation walls are typically composed of clay tile masonry with a brick veneer along the street side. The condition of the foundation masonry generally appears to be good. We observed little evidence of settlement, cracking or displacement in the original building clay tile masonry work. These walls appear to be functioning well as bearing walls for the main building. There are few window and door openings in these walls. Adding a significant number of wall openings (doors and windows) in a future renovation could be concern for these walls and may require supplemental framing.

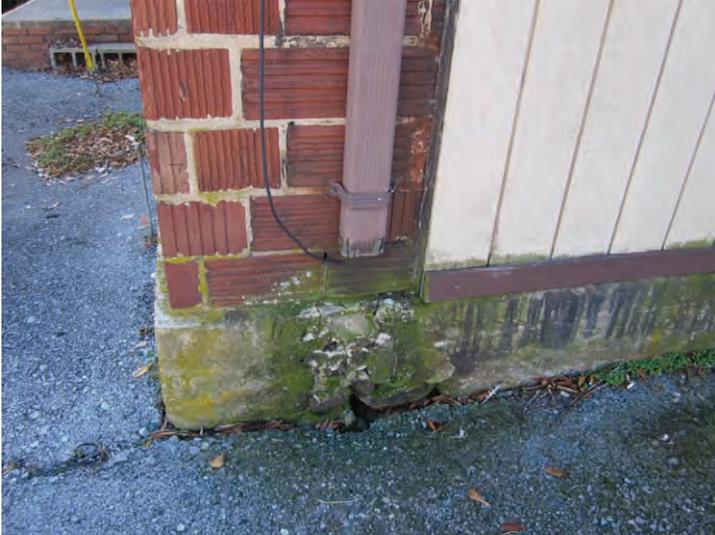
Downspout should be repaired at south wall

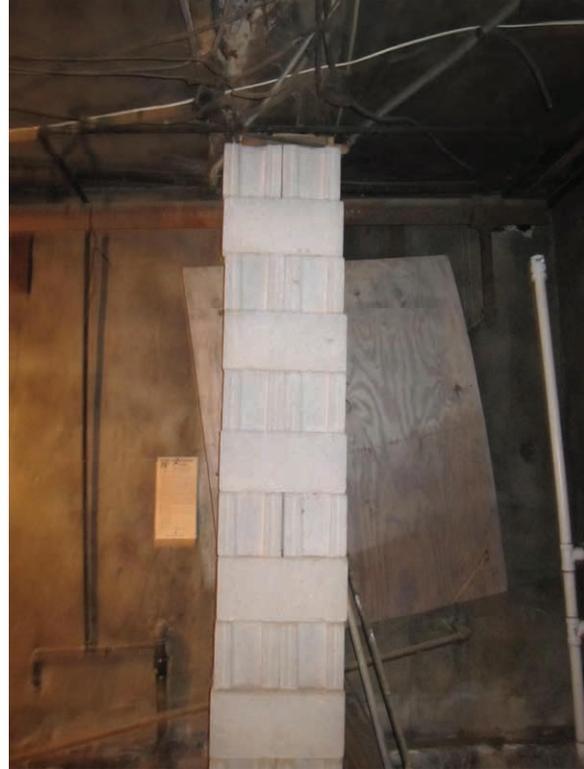
There is a drystack CMU pier in the basement boiler room located below one of the main interior timber columns. *The stability and support of this element is questionable and it should be repaired.*

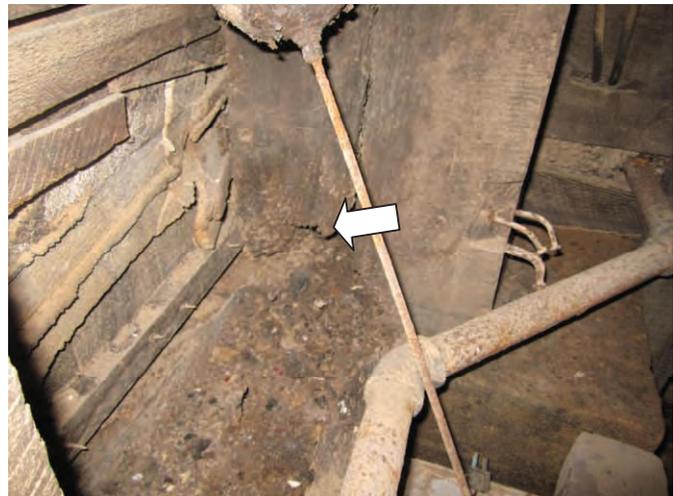
The base of one of the main interior loadbearing timber columns in the old coal room is severely damaged and decayed. There is loss of bearing and questionable support for this column. *This column element should be replaced.*

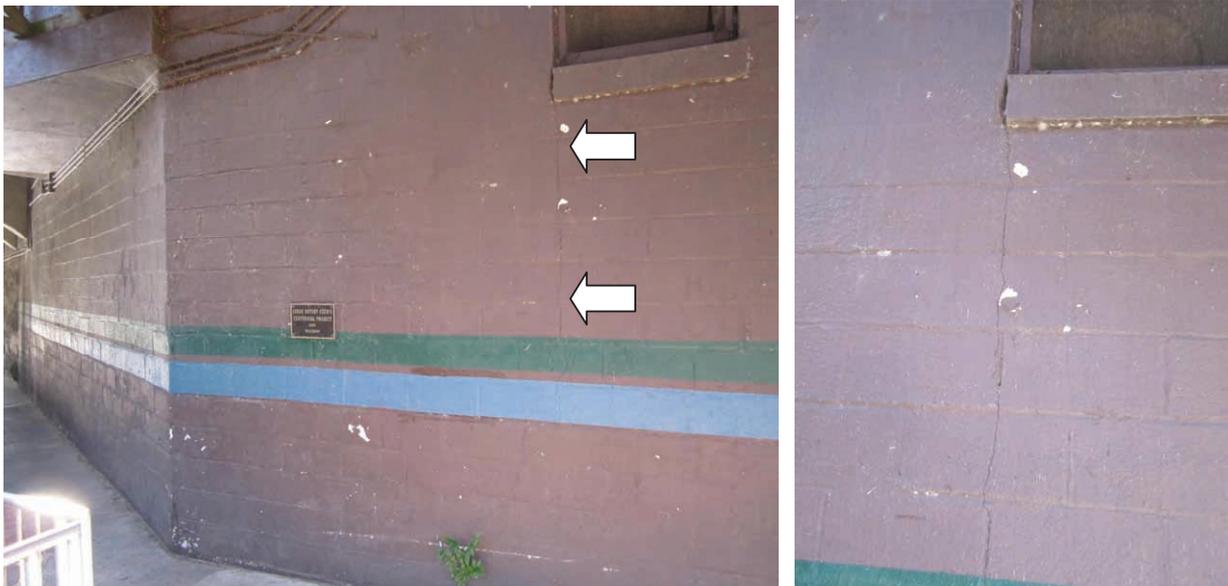
The east side building addition foundation has concrete masonry unit (CMU) walls and is located approximately 25' from the bank of the river. We observed a few areas of minor cracking in this foundation, but the mortar is generally tightly bonded and competent. There may be some settlement of the foundation in this area, but we did not observe evidence of scour or concern for support of the foundations.

East addition foundation wall cracks

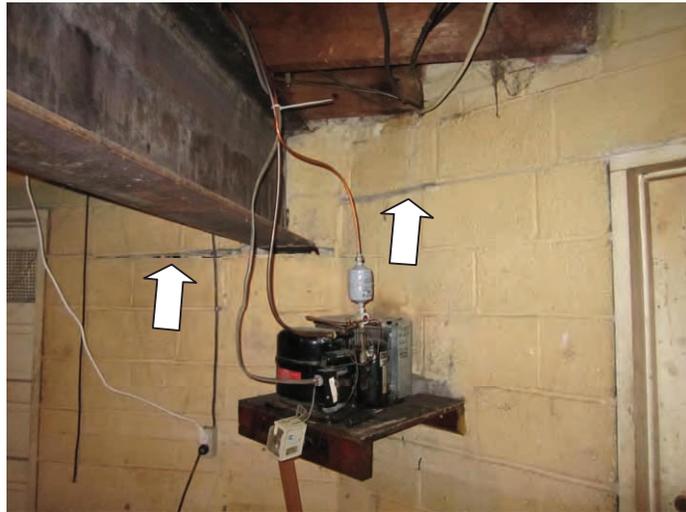
There is more significant settlement of the slab on grade in the east addition basement. Some of the interior CMU partition walls have settled and cracked below the first floor framing. This movement appears to be in the non-loadbearing partition walls and we suspect that this is caused by consolidation of fill soils below the slab on grade. We did not observe similar displacement in the foundation walls which are likely bearing at a lower elevation.

Cracks in basement partitions below steel beam.

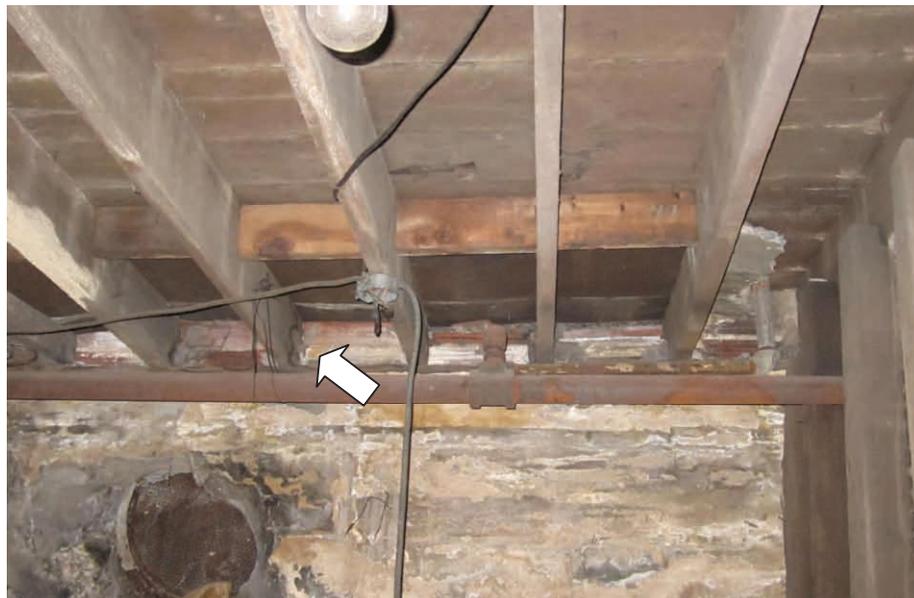
There are visible areas of water infiltration and potential damage and decay to some of the bearing ends of the joists along the front foundation wall. Further study and probing of the joist ends should be performed to determine the full extent of any damage. Where damaged, supplement treated lumber could be added.

First floor framing at front foundation wall

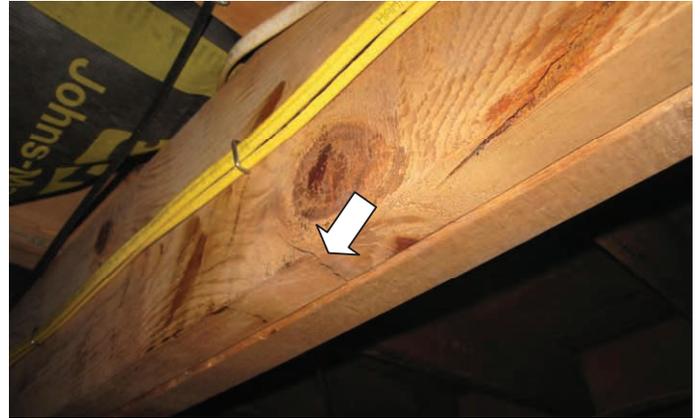
The first floor area below the restaurant bar appears to have been added after the initial construction. A double 2x8 timber beam supports the floor framing in this area. This beam appears undersized for the loading, has questionable support and is cracked at its midspan. *This condition should be repaired.*

Mid span crack

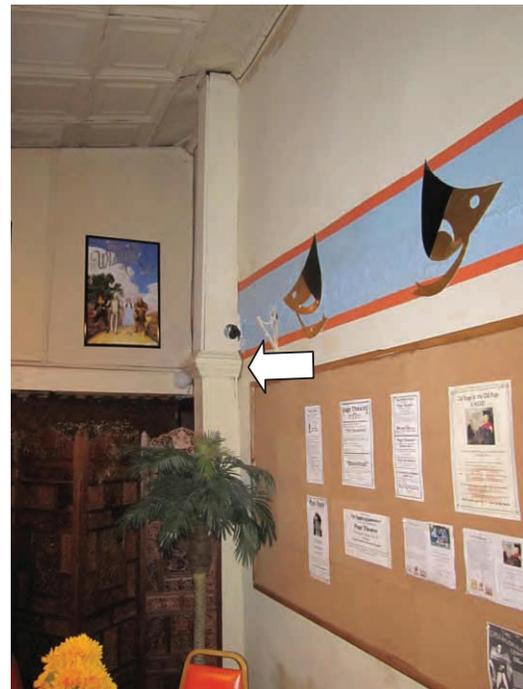
Two of the rear column covers below the mezzanine have buckled slightly and there is a drilled hole near column mid-height. *The column covers should be removed and the condition of the structural columns at these two locations should be investigated further.*

Potential hole through column below mezzanine

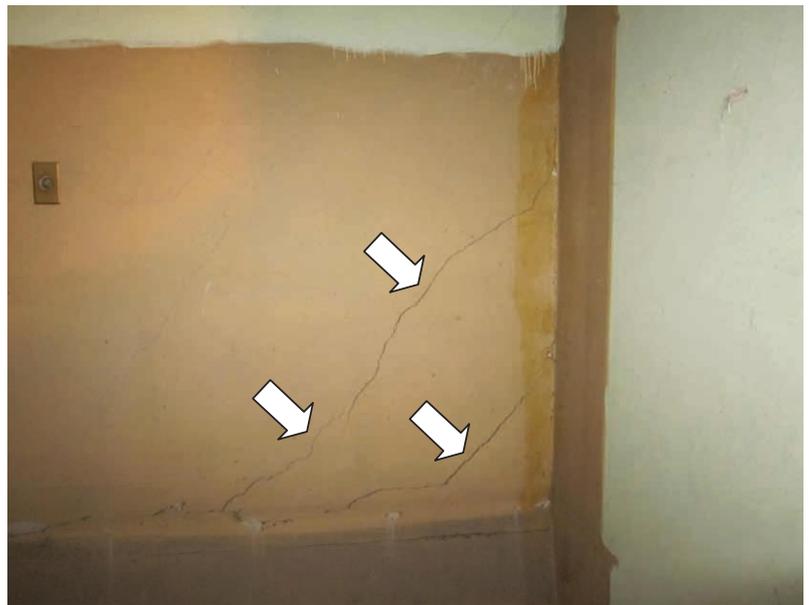
There is significant floor deflection in many areas of this floor particularly near the front of the building. There is significant plaster cracking in the second floor interior walls. Cracking is most severe in areas where floor deflection is greatest. The crack patterns in these walls are consistent with the observed deflection in the floors. *The beams, joists and beam/column connections in the front of the building should be exposed, inspected and reinforced as appropriate prior to any occupancy of the second floor.*

Second floor plaster cracking.

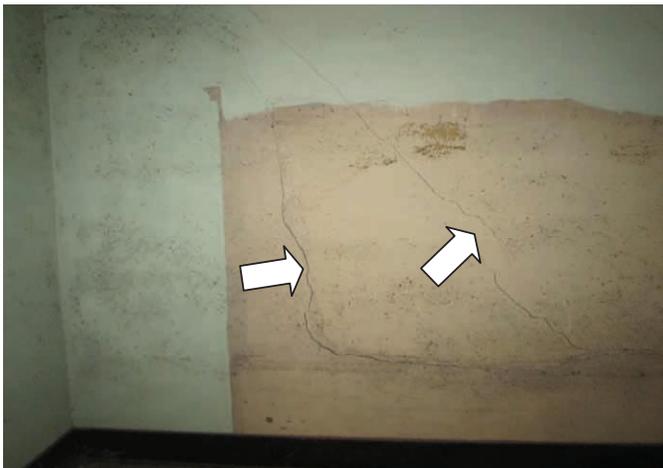
Second floor plaster cracking.

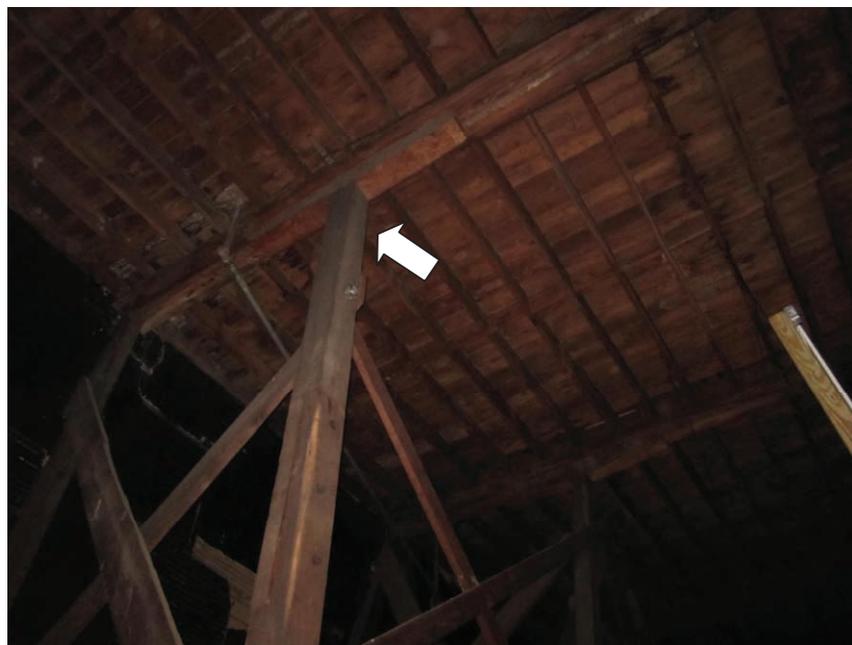
A shoring system has been installed to support the trussed timber beams above the stage at the rear of the building. In our experience, these beams are problematic over time as wood creep and shrinkage causes excessive deflection and loosening of the tie rod connections. *We recommend that these beams be permanently shored, reinforced or replaced before removing the shoring or permitting any type of occupancy of the second floor.*

Shoring of beams over stage.

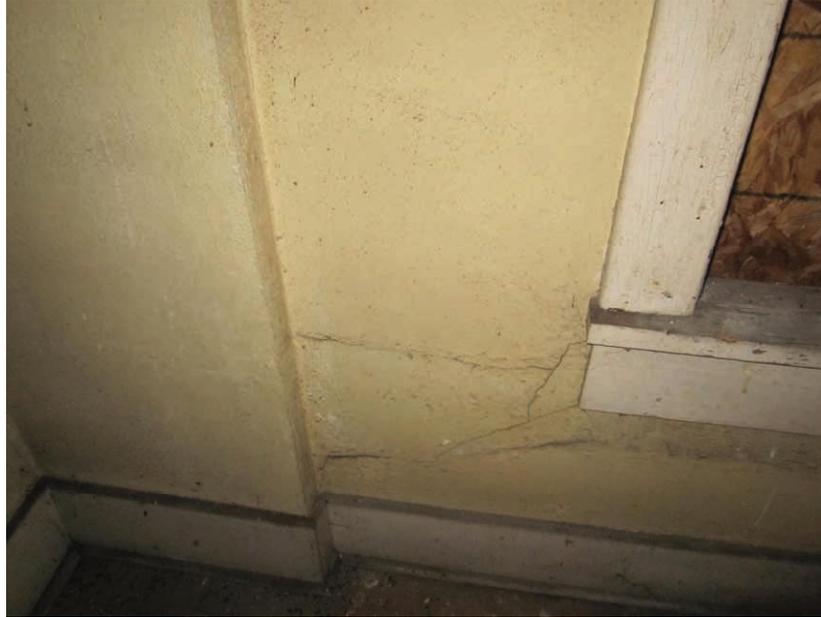
There are a few areas of exterior wall cracking on the second floor. These conditions are relatively minor compared to the interior wall cracking and generally are not significant to the loadbearing masonry.

Second floor exterior wall plaster cracking.

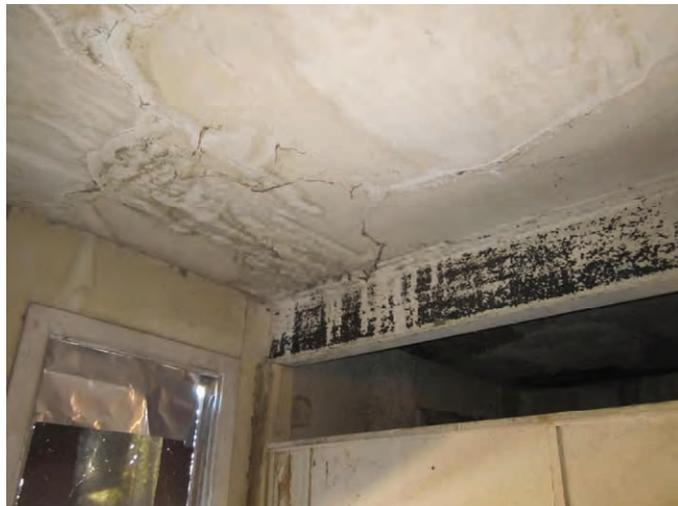
The roof framing consists of sloped 2x lumber rafters supported by second floor partition walls with some beam and column framing at the rear. The roof slope is nearly uniform and is a low slope down to the rear of the building. The rafters are generally 2x6's spaced at 24" and span about 16'. Many of the roof rafters are sagging and there is some evidence of past water damage. *The typical rafters are undersized by current building code standards and should be reinforced. Water damaged framing should be repaired.*

Prior water leakage and potential damage and decay to roof framing. Leaking appears to have been repaired.

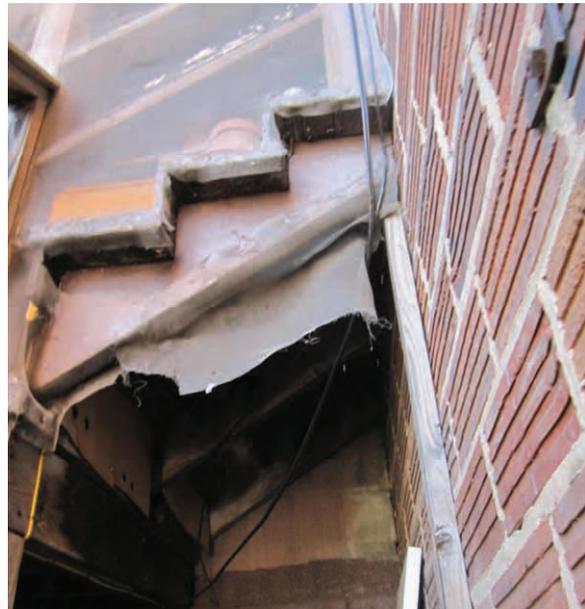
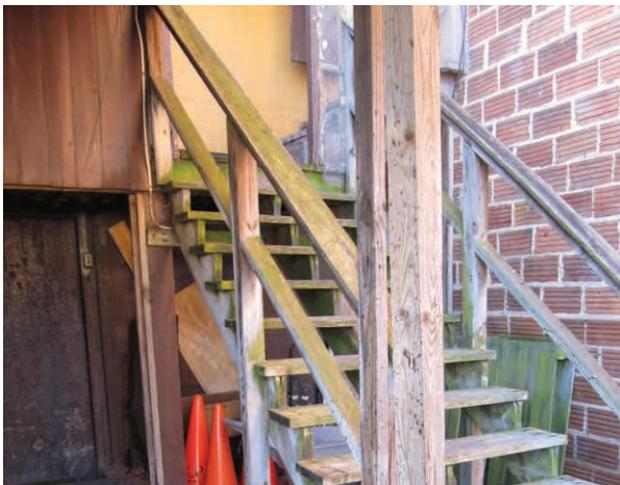
The rear kitchen and mezzanine access stair is wood framed. The framing is water damaged. The connections of the stair stringers to the landing and walls are questionable. The stringers are undersized for building code exit stair loads. *This stair should be replaced.*

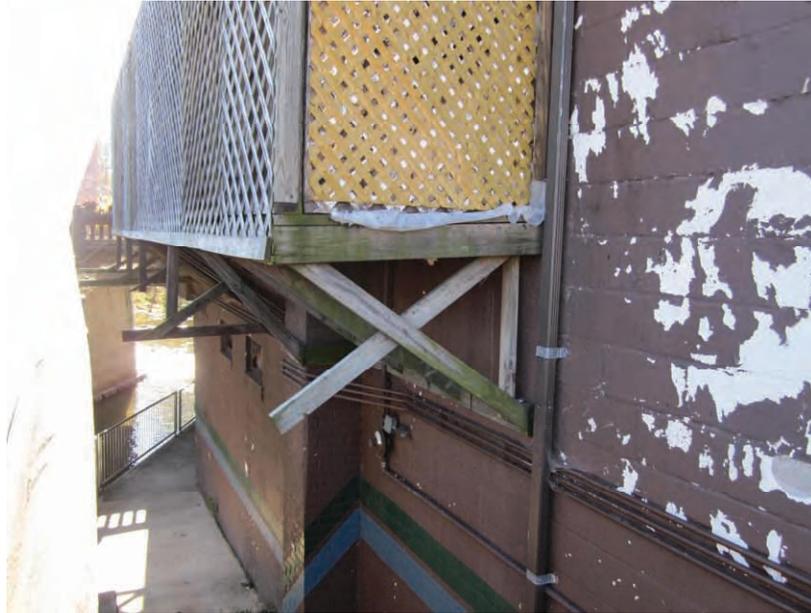
An exterior mechanical equipment platform is suspended from the side of the kitchen walls. The anchorage and framing of this platform appears undersized for the loads. *This platform should be repaired or replaced.*
