BRIDGE THEATER FEASIBILITY STUDY

LURAY, VIRGINIA

FEASIBILITY REPORT

March 2012

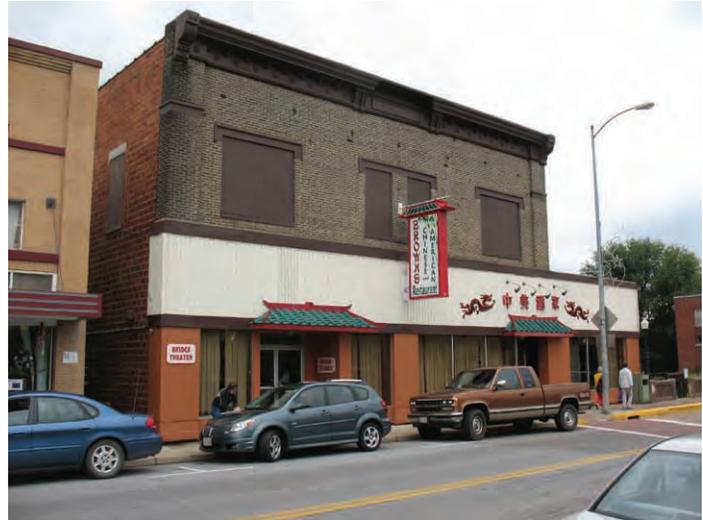
The upper story windows on the front and side elevations are typically boarded-up with painted plywood. The original wood windows with one-over-one light patterns still exist but vary in condition with a number of them broken, missing, or removed from their frames. Pressed metal hoods embellish the paired upper-story window openings on the front facade.

View of the building's front facade.

1. Remove metal siding, wood panels, storefront, lattice screen and support system from the front and side facades to expose the original building fabric. Repair damage to the masonry with materials to match existing in color, texture and size. If the original lower facade structure is different and/or cannot be re-built as illustrated, contact the Main Street Architect for recommendations prior to proceeding with work.

2. Remove panels from upper facade window openings. Repair any damage to masonry with materials to match existing in color, texture and size. Repair windows to operable condition. Provide new windows where existing windows are missing to match existing design and materials of remaining windows.

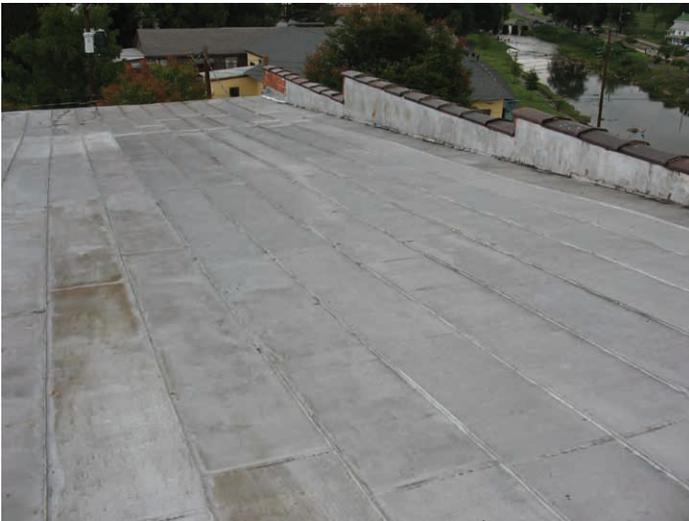
The existing standing seam galvanized metal roof is reported leaking and has a number of locations that have been patched or that are potentials for leaks in the future. It has an intermediate ridge, which directs water to the front and rear of the building. The water directed toward the front of the building exits through a scupper in the east parapet wall at the southeast corner. An enclosure that presumably includes the downspout can be seen on the building exterior in this location. The water directed toward the rear drains into a metal gutter and downspout that empties onto grade. A section of the clay tile parapet wall coping is missing and a rubber membrane has been added to temporarily address this. The roof of the one story addition was not accessed for this report.

View of the roof looking toward the rear of the building.

6. Provide new signage as shown in elevations.
7. Since it will not be visible from the ground, provide new rubber membrane roof on both the one and two story sections of the building. Provide new gutters and downspouts as needed. Repair coping with matching materials.

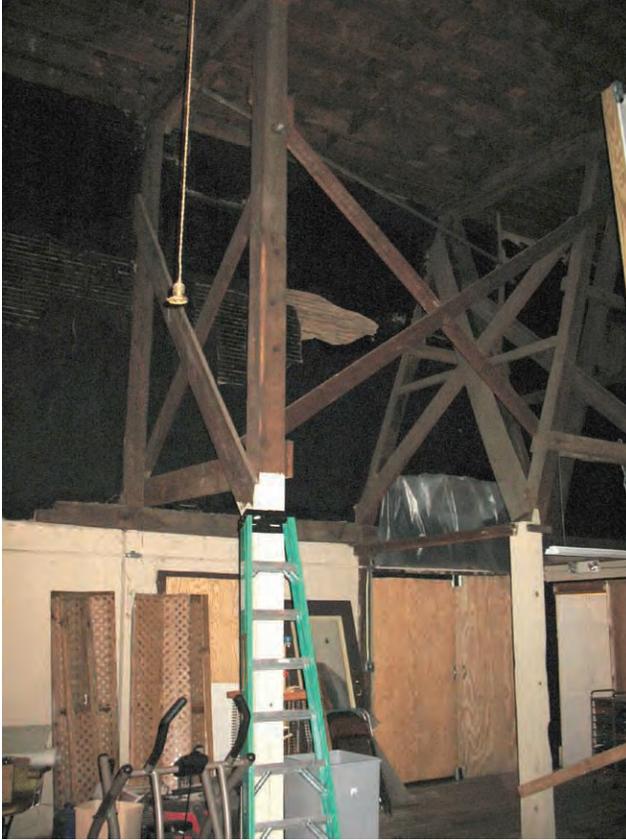
View of framing in stage area.

A former flyloft above the theater's stage may have been later decked over at the second floor level. This would explain why the structure in the rear stage section of the theater is different from the structure on the opposite side of the proscenium wall. Exposed ganged wood girders running lengthwise and perpendicular wood joists are visible above the stage. An unusual timber-framed structure at the beneath this at the rear of the stage appears to laterally brace the rear facade as well as support the floor above. The wall that contains the proscenium stage opening aligns with structural elements on the top floor.

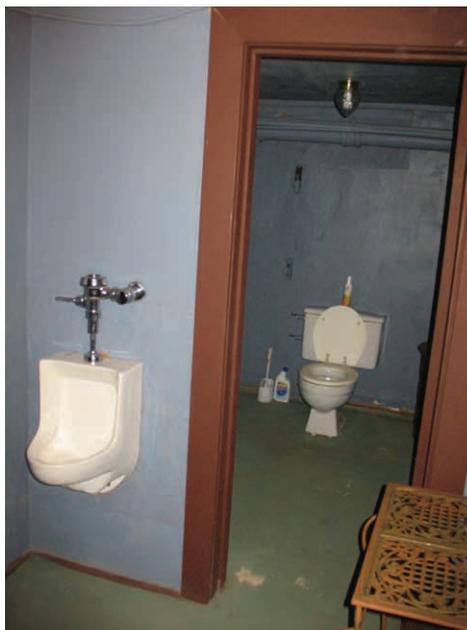
Restrooms at the back of the theater have a low quality, functional level of finish and do not meet ADA standards.

Existing restroom next to theater.

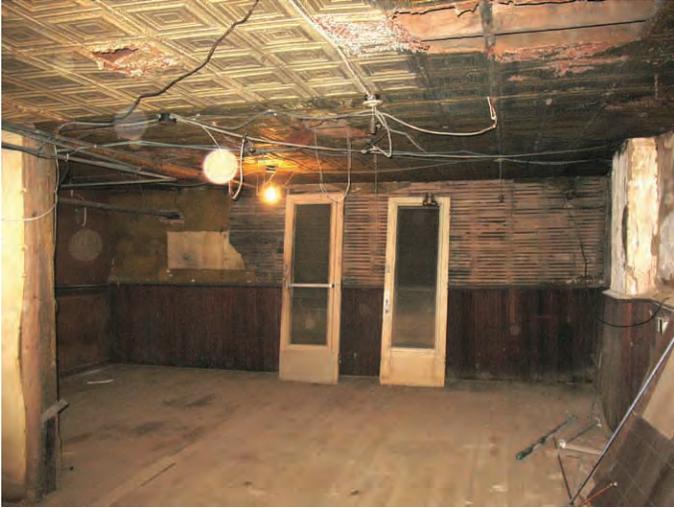
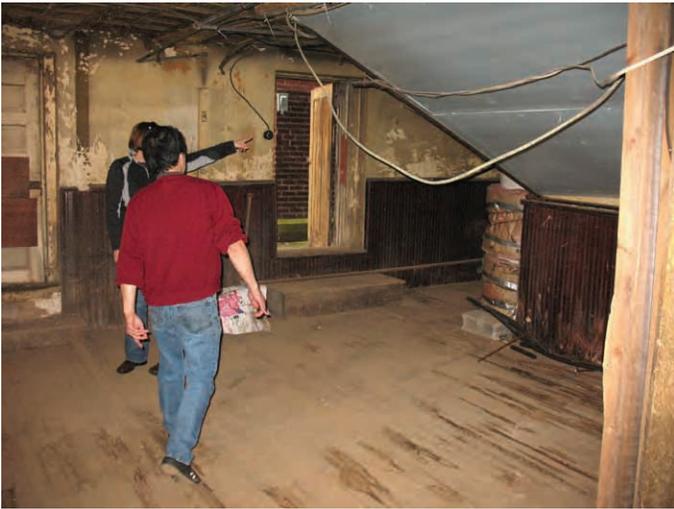
Room in the basement area at southwest corner of the building.

Two rooms accessed from exterior doors in the alley are approximately on the same level as the theater. A large room in the southwest corner of the building has a wood wainscot that is in relatively good condition, but the wood floor is spongy and likely was built on sleepers set on-grade which have rotted. The other room is a small bathroom that is no longer used.

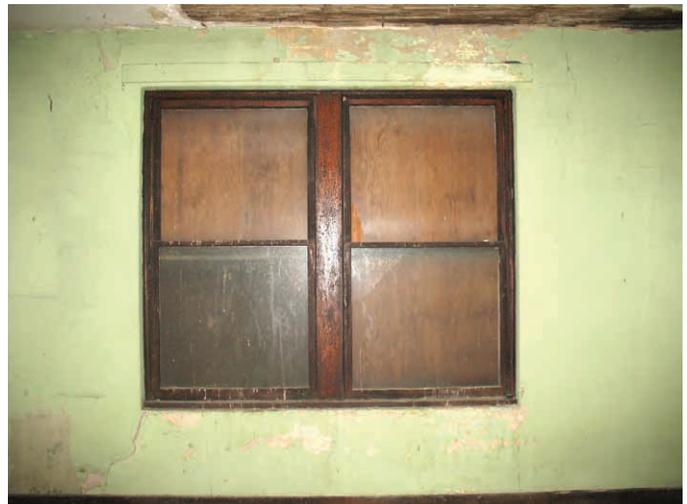
Much of the original trim and the associated doors are in fair condition. The windows, while covered with plywood, vary in condition - some are missing or damaged while others appear to be in serviceable condition.

View of interior treatment of typical window on the second floor.

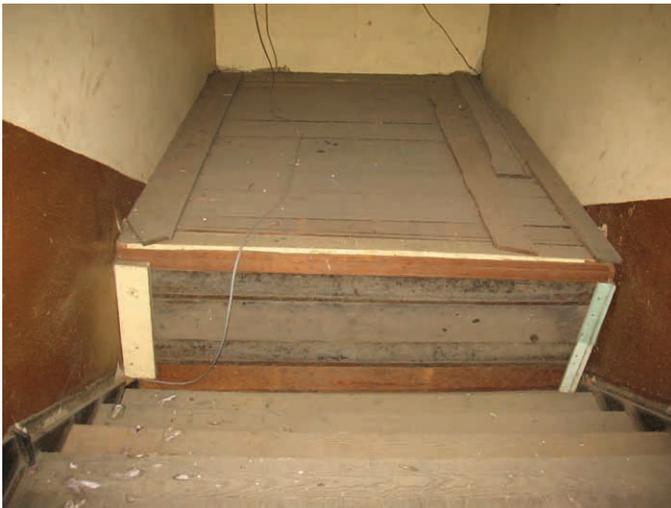
View of partially removed stair leading down from the balcony to the Main Street entrance.

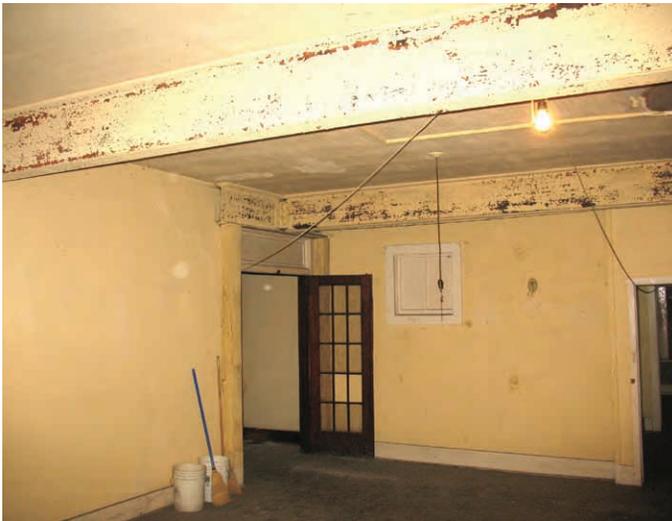
View of exposed steel beams on north end of second floor.

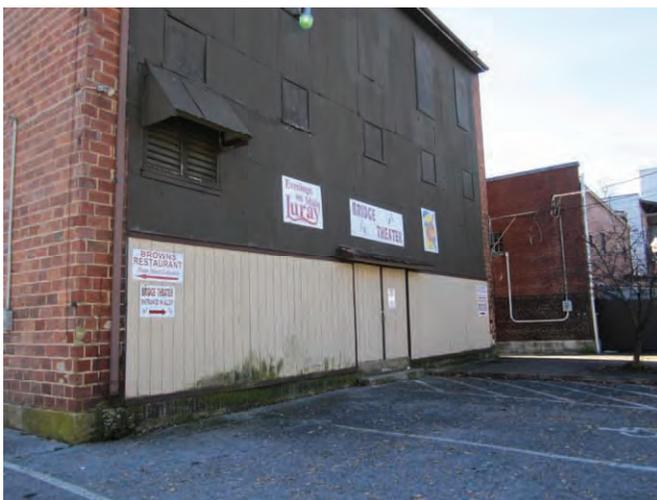
South theater wall

The foundation walls are typically composed of clay tile masonry with a brick veneer along the street side. The condition of the foundation masonry generally appears to be good. We observed little evidence of settlement, cracking or displacement in the original building clay tile masonry work. These walls appear to be functioning well as bearing walls for the main building. There are few window and door openings in these walls. Adding a significant number of wall openings (doors and windows) in a future renovation could be concern for these walls and may require supplemental framing.

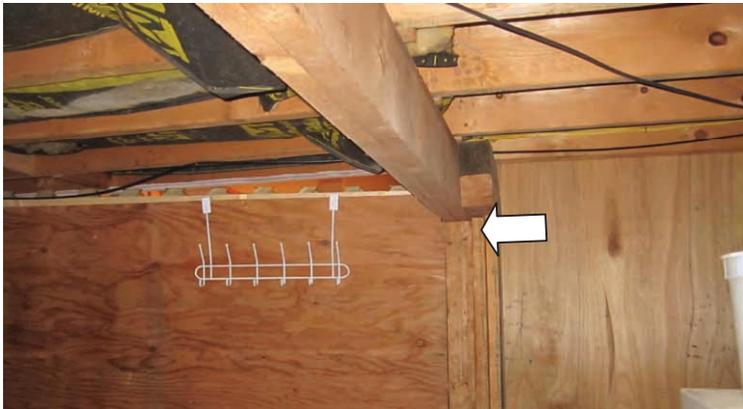
The first floor area below the restaurant bar appears to have been added after the initial construction. A double 2x8 timber beam supports the floor framing in this area. This beam appears undersized for the loading, has questionable support and is cracked at its midspan. *This condition should be repaired.*

Double 2x8 beam support

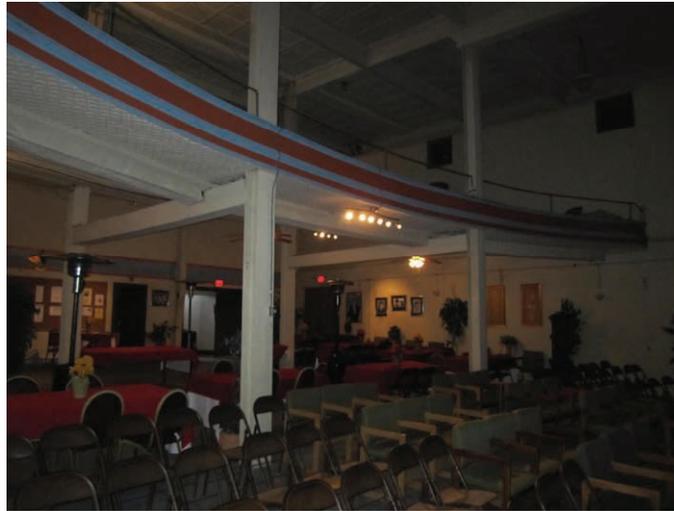
The mezzanine floor framing consists of sloped wood joists supported by timber beams and built-up steel columns. The joists were not accessible, but the floor did not show excessive deflection or cause for concern with the framing.

Mezzanine with exposed timber beams.

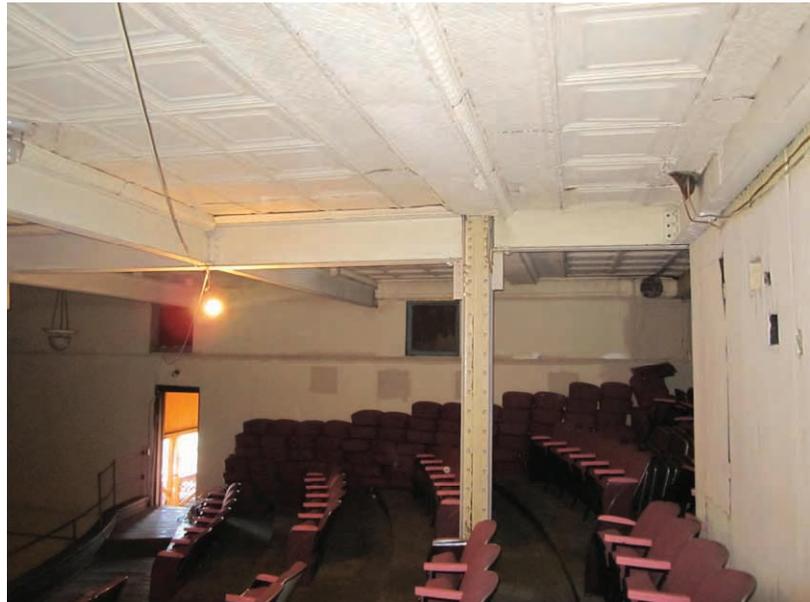
The second floor framing generally consists of dimension lumber joists supported by a combination of steel beams, timber beams and trussed timber beams. Trussed timber beams are located over the rear stage. There is a steel girder over the proscenium and steel beams over the mezzanine. Timber beams support the floor joists at the front over the restaurant. Many areas of the floor framing are concealed by ceilings. It appears that this level is also functioning as a transfer level supporting much of the roof framing above. As noted below, we have concerns about the capacity of this floor system in its current condition.

Second floor steel framing over mezzanine.

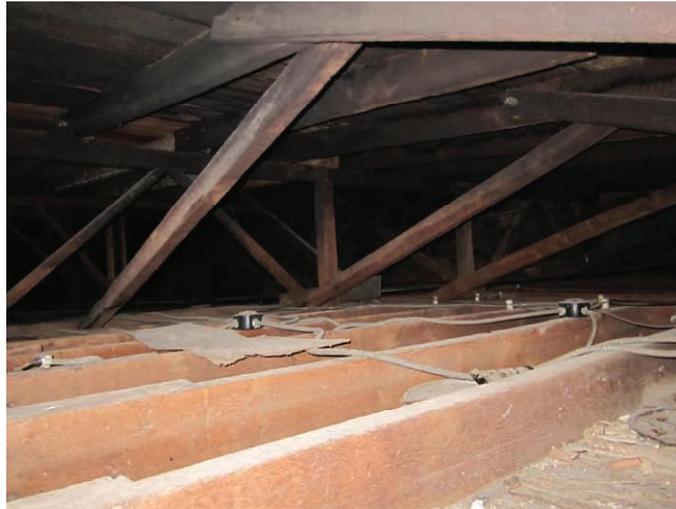
The roof framing consists of sloped 2x lumber rafters supported by second floor partition walls with some beam and column framing at the rear. The roof slope is nearly uniform and is a low slope down to the rear of the building. The rafters are generally 2x6's spaced at 24" and span about 16'. Many of the roof rafters are sagging and there is some evidence of past water damage. *The typical rafters are undersized by current building code standards and should be reinforced. Water damaged framing should be repaired.*

Typical roof rafter framing above ceiling joists.

Prior water leakage and potential damage and decay to roof framing. Leaking appears to have been repaired.
